Manhole Inspection Summary

Manhole # S41C__050MH

Insp Date: **12/30/08 10:13 AM**

Location Address: **n caroline st**

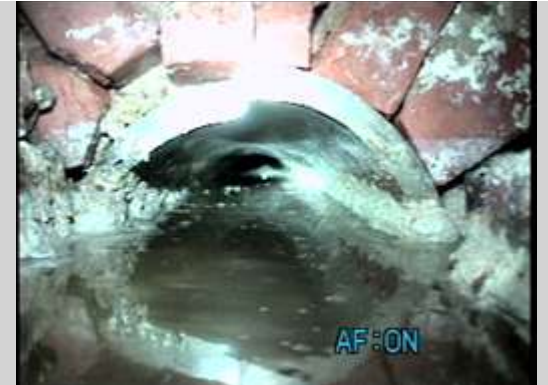
12 O'Clock Outflow

8 in. Circular Gravity Sewer
Pipe Out @ 12 O'Clock

Invert Depth: 13.55 (ft.) Flow Characteristics: **Slow**

Infiltration: **None** Pipe Seal Cond: **Unknown**

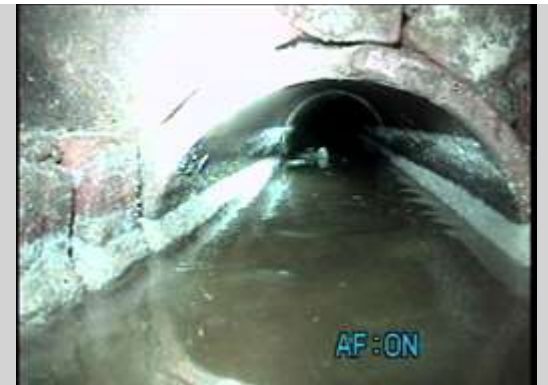
8 O'Clock Inflow

8 in. Circular Gravity Sewer
Pipe In @ 8 O'Clock

Infiltration: **None** Pipe Seal Cond: **Unknown**
